# Catastrophic failure of a cooling tower fan

*Titus Generating Station*

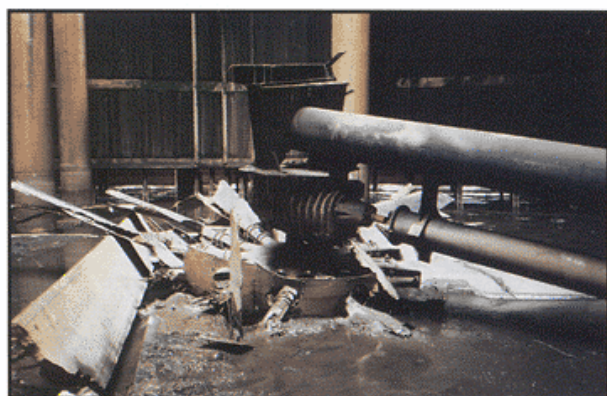
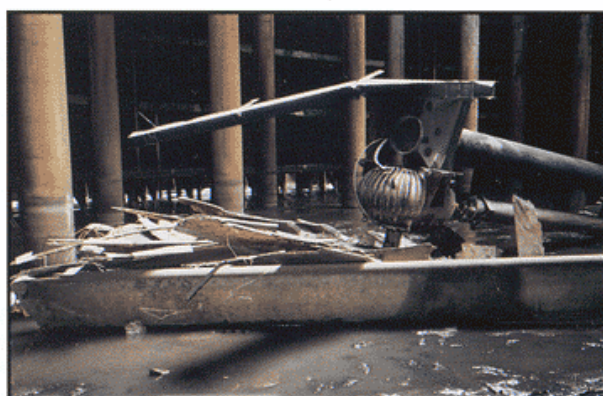
Figures 1 and 2

Destroyed cooling tower fan and gear reducer lying on floor of basin.

In January 1992, plant personnel working outside the cooling tower heard a loud noise coming from within and notified the station operation department. Operation personnel found that the #2 cooling tower fan, motor and gear box had been completely ripped from their support. The entire fan assembly had fallen into the basin 20 metres (60 feet) below the tower deck (Figures 1 and 2). The portion of the walkway that supported the motor was ripped away, leaving a gaping hole (Figure 3).

Investigators believe that the failure began when one fan blade sheared off completely, causing significant unbalance. The fan's vibration switch failed to shut it down, and the unbalance forces destroyed it. Investigators found that the switch failed because of corrosion caused by moisture that had entered the casing. This prevented the vibration switch from reacting to the vibration caused by the unbalanced fan.

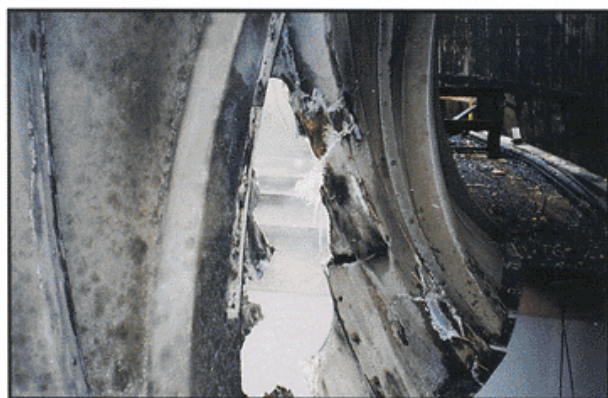
Figure 3

Fan stack showing a gaping hole where the motor had been.

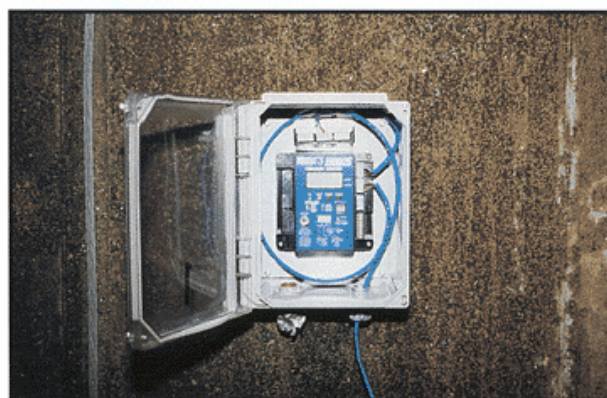
Figure 4

Trendmaster 2000 TIM & 1900 Series Monitor in weatherproof housing, mounted on outer wall of cooling tower.

The team researched various online monitoring and diagnostic systems. They compared the systems' initial hardware and installation costs. They compared the amount of training required to use the systems. They also looked at how easy the systems were to expand, because the station was planning an aggressive predictive maintenance program. The team decided to use an online Bently Nevada Trendmaster® 2000 System with 89129 Low-cost Accelerometers and 1900 Series Monitors. The system was installed on the eight cooling tower fans in early 1994 (Figure 4).

Each cooling tower fan now has two permanently-mounted accelerometers, one on its motor and one on its gear reducer. The accelerometer on each gear reducer is connected to a 1900 Series Monitor, which is configured to shut down the fan on high vibration. All eight 1900 Series Monitors are connected directly to a single Trendmaster 2000 signal cable. The same cable is connected to the accelerometer on each fan's motor through eight Transducer Interface Modules (TIMs). The single cable runs from the cooling tower to the Engineering Room, where it is connected to the online Trendmaster 2000 System computer. Each fan's 1900 Series Monitor and TIM is mounted together in a weatherproof NEMA 4 housing. Each weatherproof housing is mounted on the cooling tower wall near the fan's motor.
